FM SAFETY ALERT

Near Miss 11-21-06 Electrical Work

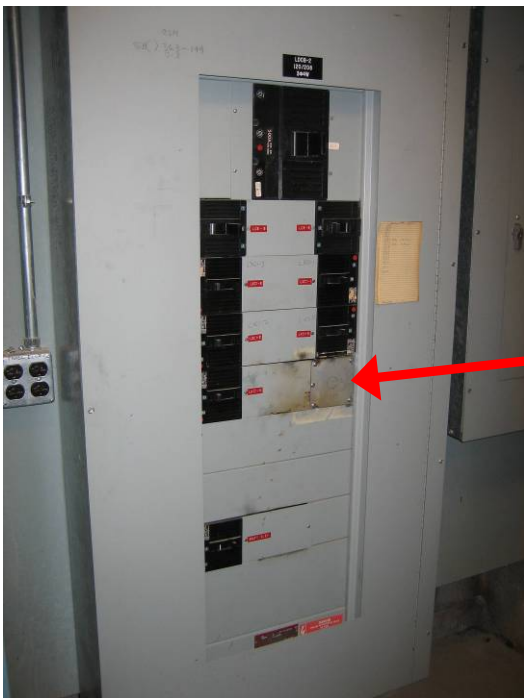
An electrician was working on an electrical panel (500 amp) where a breaker was missing, exposing live parts. While screwing in a cover over the left side of this opening, the right side of the cover slid in to the open area and contacted the live parts. An arc flash occurred and the circuit breaker tripped. The employee was standing off to the side and wearing the appropriate personal protective equipment (PPE) (coat, gloves, hard hat, face mask). He was not injured.

Electrical panel involved in incident

- 1.) Better Planning – plan the task for the weekend so LO/TO can be performed with minimal effects on the building.
- 2.) Better Communication – if a task should involve two people and only one is assigned, the employee should stop work and alert their supervisor.

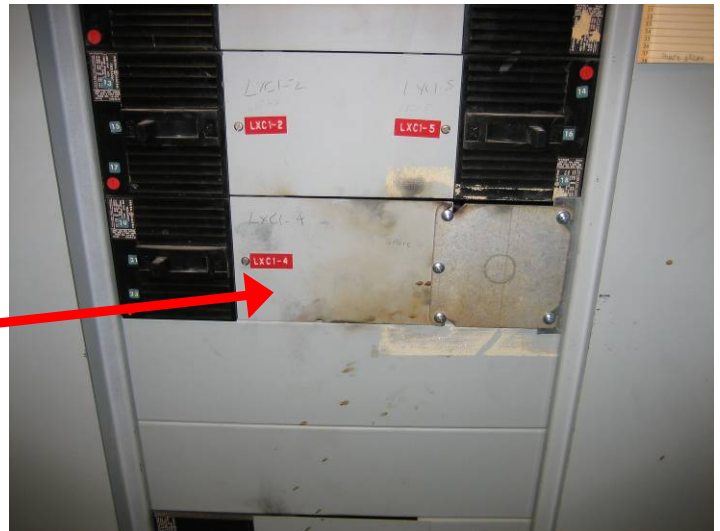
Lockout/tagout (LO/TO) was not used on the equipment prior to beginning work (this would have cut power throughout the entire building including lights, elevators, and fans). This left the possibility of contacting live parts. If work on live equipment was to be performed, a team of two people should have completed the task.

Close up view of installed cover. Right side of this cover contacted live parts during installation resulting in an arc flash.
